(21) Report on
OPERATION UPHOT-KNOTHOLE,

Project 3.20(12)

(6) BLAST AND THERMAL EFFECTS
OF AN ATOMIC BOMB ON TYPICAL
TACTICAL COMMUNICATION SYSTEMS (17) (8)

(10) by Jacob Eggert and
Elmer R. Higgins

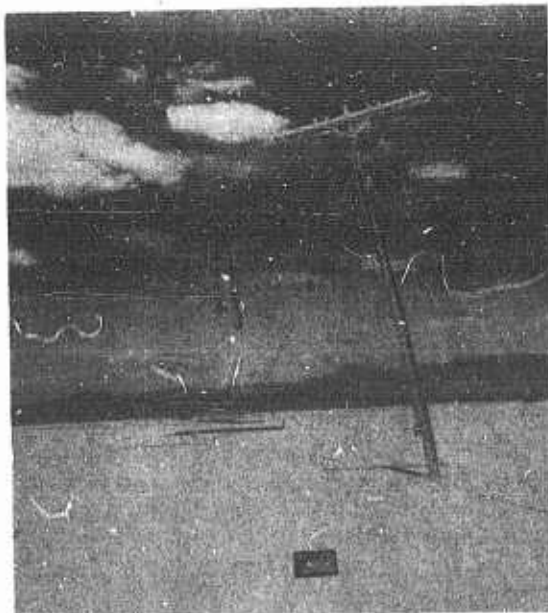
Fig. 3.42 Shot 9, Test Group 27, Transverse Pole Line, Poles B-1 through B-8, B-8 in Foreground. Right Shows Close-ups of EE-8 Telephone and TM-184 Terminal Strip on Shielded Side of Pole B-8. (Top left-before, Bottom left-after, Top right-before, Bottom right-after) 4450 ft, 35 cal, 7 psi.

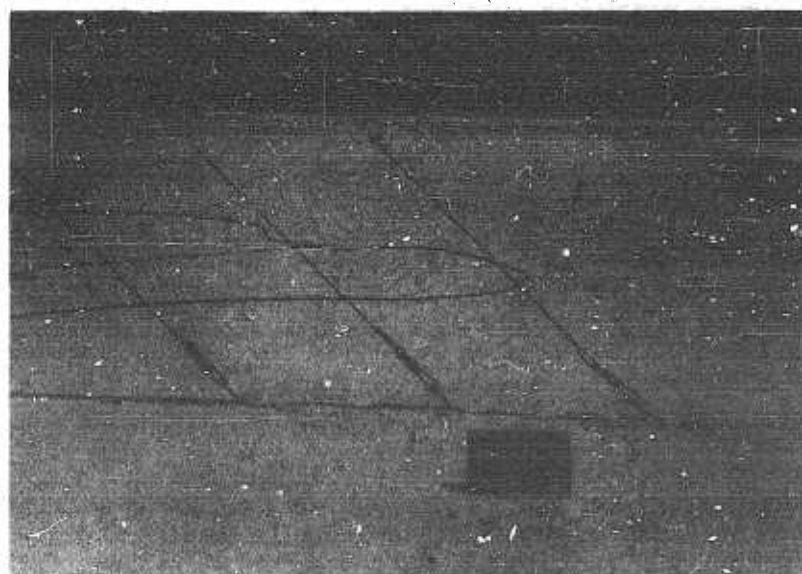
Fig. 3.51 Shot 9, Test Group 30, Transverse Pole Line, Triple Guys and Anchors on Pole A-8. (Top-before, Bottom-after)
5425 ft, 25.5 cal, 5.6 psi.

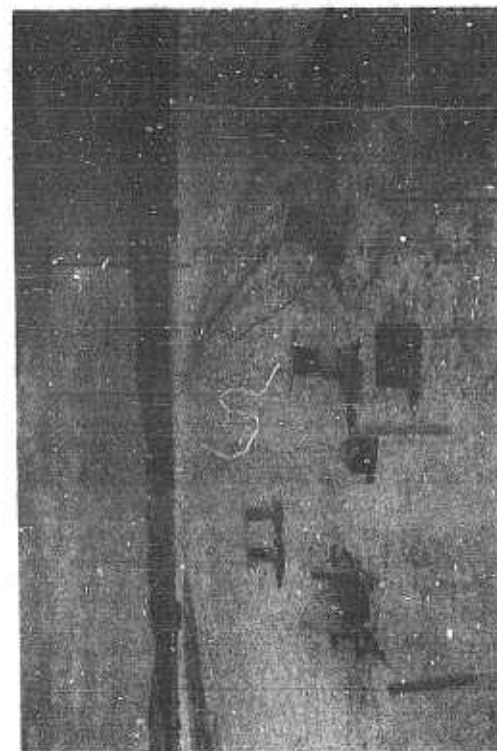
Fig. 3.52 Shots 9 and 10, Test Groups 2 and 2A, Surface Laid Wire and Cable. (Top left-before 9, Top right-after 9, Bottom-after 10) In Top View Cable Reels in Readiness to Lay along Ground Zero Just Prior to Shot 9. In Bottom View Photo Taken 2100 ft North Looking Toward Ground Zero. Shot 9, 1250 ft, 113 cal, 16.6 psi. Shot 10, 2100 ft, over 65 cal, 7.5 psi (at 2100 ft)

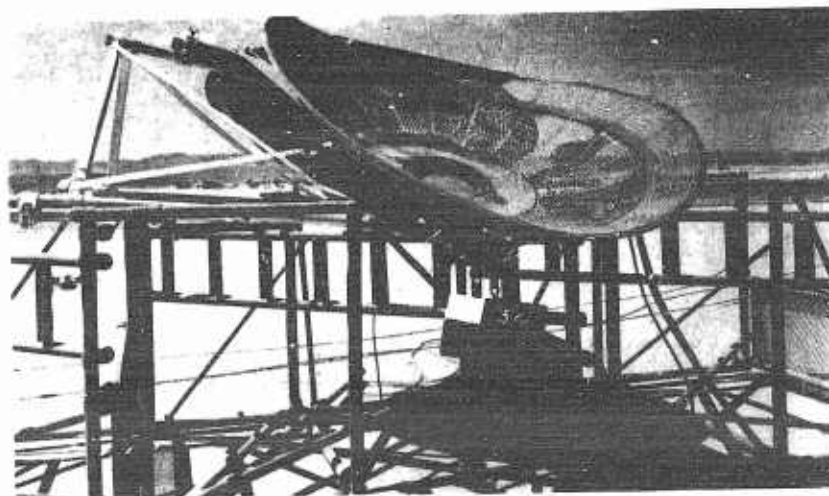
Fig. 3.89 Shot 9, Test Group 34, Tower, 120 ft.
(All after Photos Showing Damage Details.)
4350 ft, 36 cal, 7.2 psi.

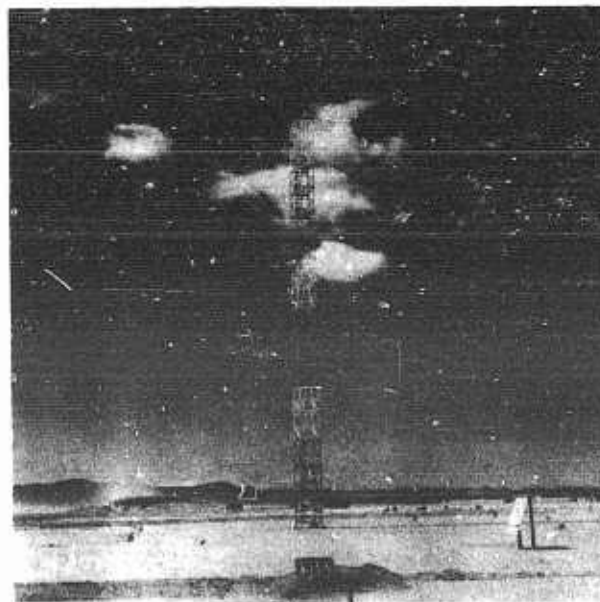
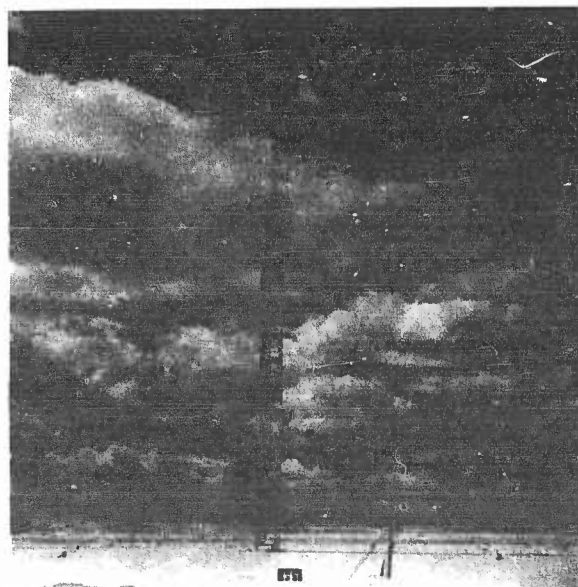
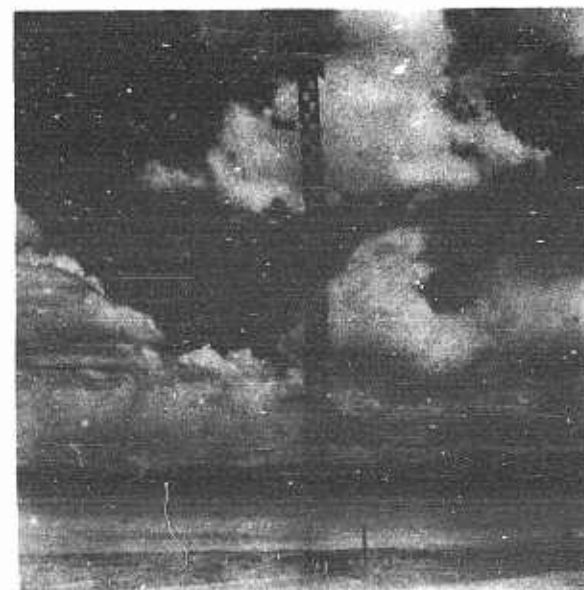
b. RESULTS: Severe damage by blast forces. Tower did not collapse but received sufficient damage to leave it unsafe for use. Parabolic reflectors, Davit MX-1215/U and the manila hauling line received no blast damage. Scaffold Tower Bracket MT-1157/G was slightly distorted. The tower base section had the two vertical members facing GZ bent toward the inside of the tower. The assembled tower twisted approximately 10° from the forth guy level to the top. The section above the fourth guy level was severely damaged with members twisted and bent. Some of the shackles at guy to anchor terminations were bent.

Fig. 3.90 Shot 9, Test Group 35, Tower, 120 ft. (Top-before, Bottom left-Side View Looking West-after; Bottom Right-Side View Looking East-after.) (Note Buckle in Tower.) 5350 ft, 19.5 cal, 4.6 psi.

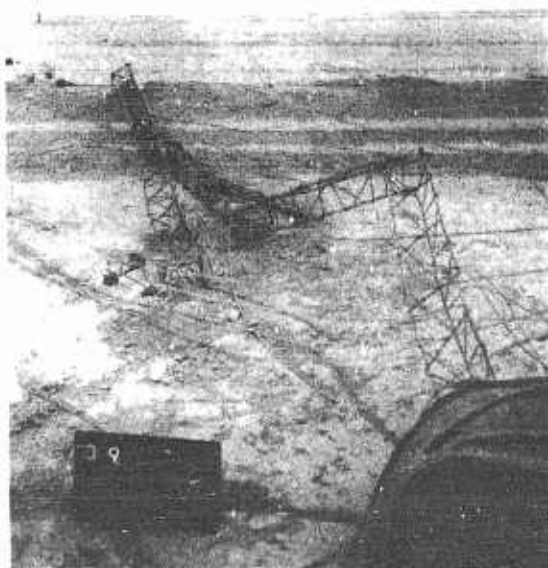
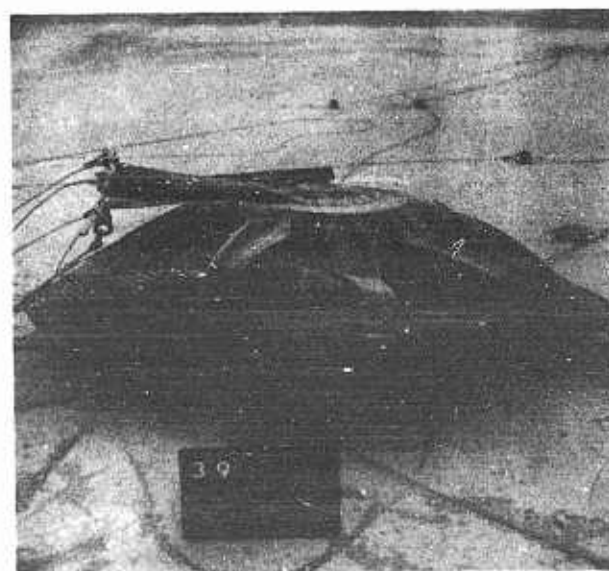
Support was severely damaged by the blast forces. The mast buckled at the joint of the third section from the top. The mast remained upright up to the joint of buckling. Because of the construction it would be necessary to replace the entire unit. Light thermal

Fig. 3.94 Shot 9, Test Group 39, Antenna Mast AB-26/CR. (Top left-close-up, after; Bottom right-Reflector, after)
4050 ft, 40.5 cal, 8 psi.

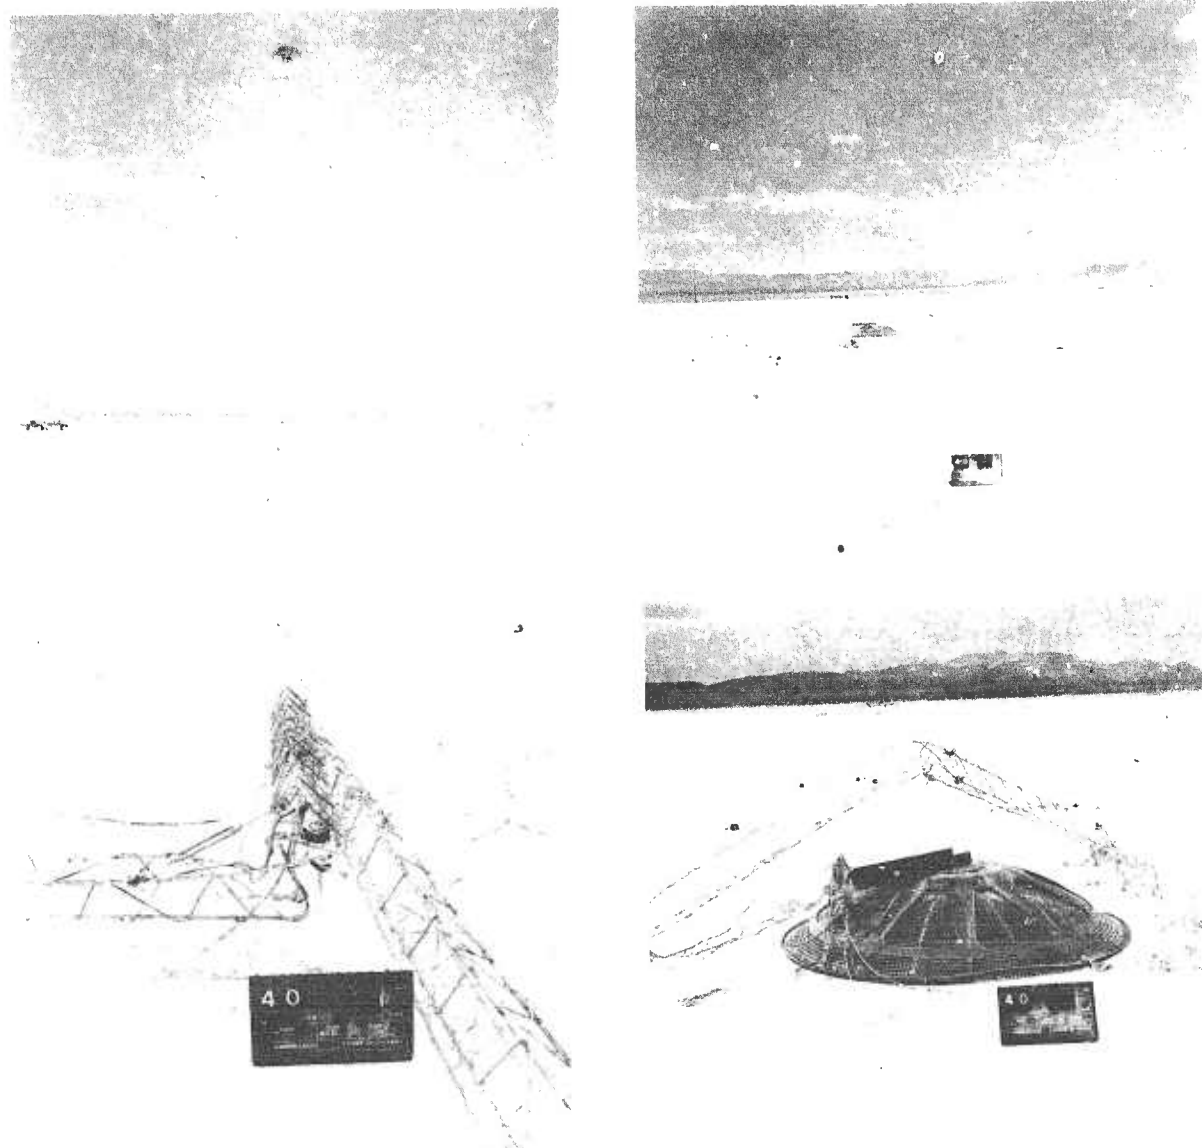
Fig. 3.95 Shot 9, Test Group 40, Antenna Mast AB-26/CR.
 (Top Left-before, Top right-after, Bottom left-close-up, after,
 Bottom right-Reflector, after) 4600 ft, 32.5 cal, 6.8 psi.

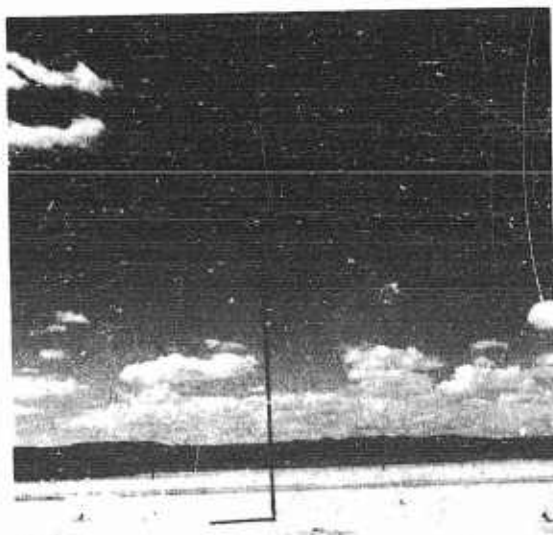
Fig. 3.98 Shot 9, Test Group 43, Antenna System, AS-19/TRC-1.
(Top left-before, Top right-after, Bottom left, bent
Mast-after, Bottom Right-Broken Top of Mast)
4900 ft, 29.5 cal, 6.2 psi.

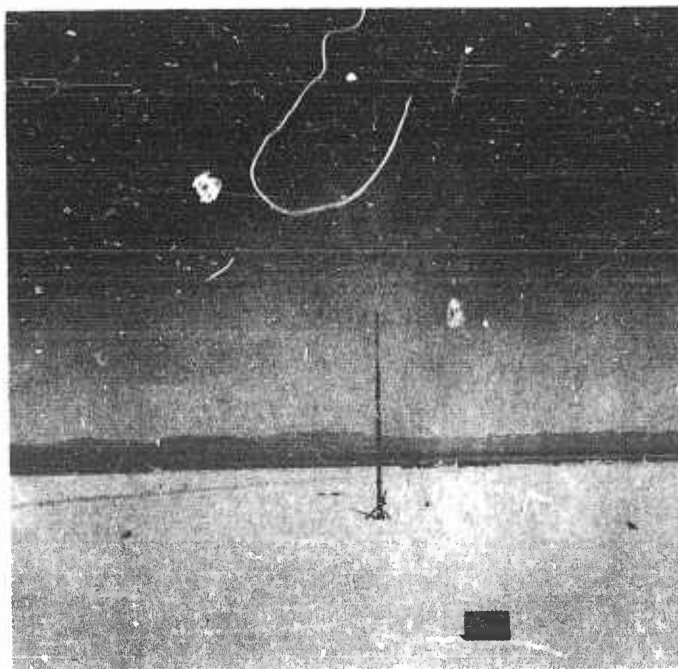
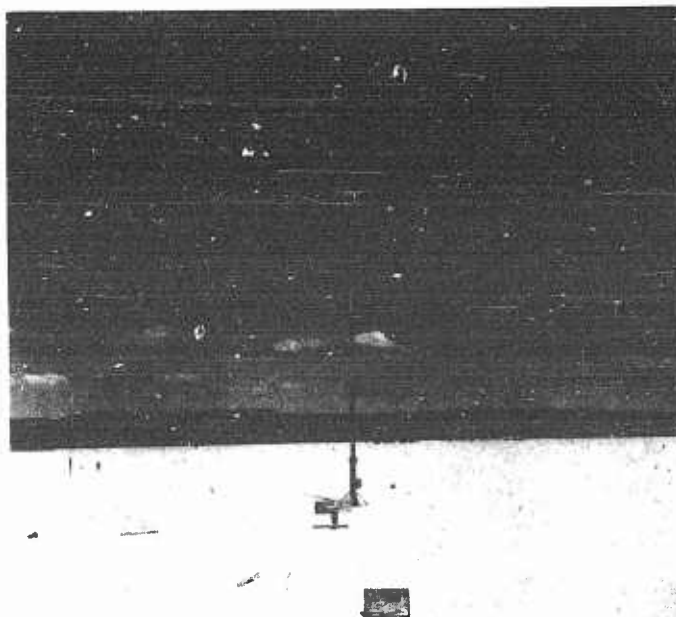
Fig. 3.105 Shot 9, Test Group 50, Antenna Mast AB-224/U.
(Top-before, Bottom-after)
5575 ft, 25 cal, 5.4 psi.

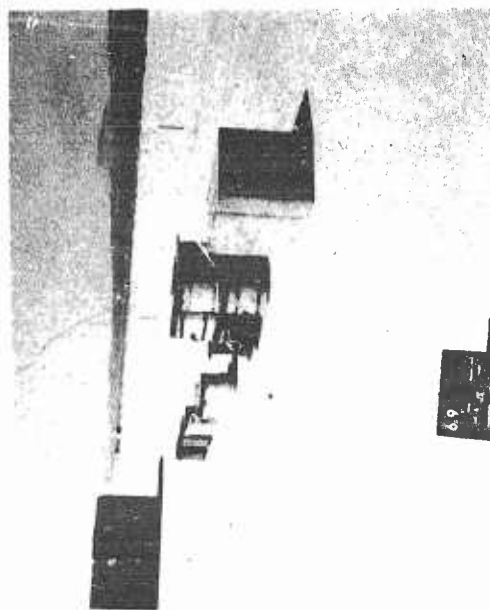
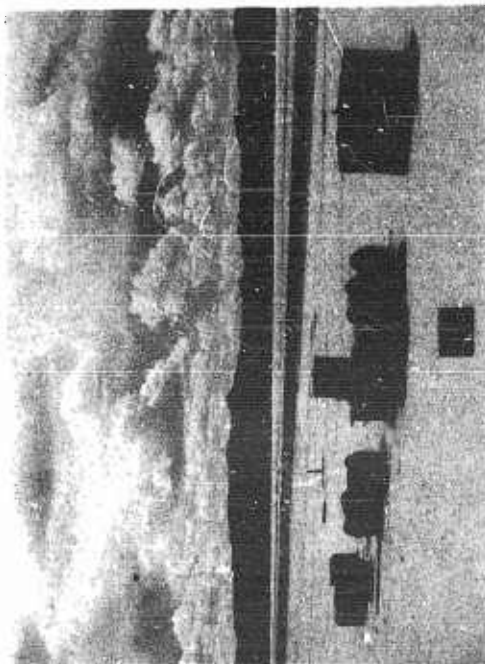
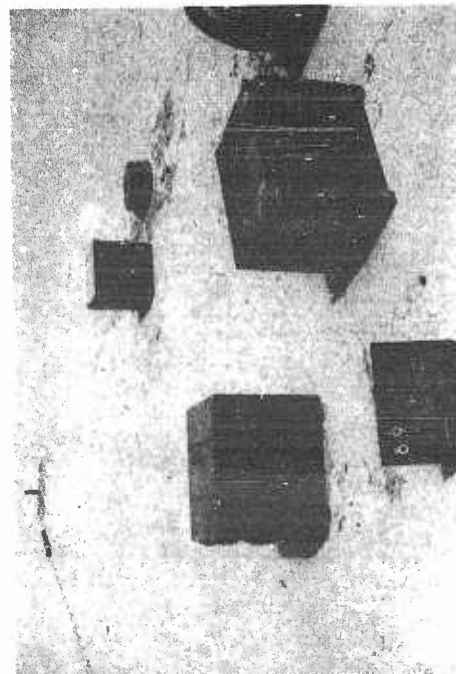
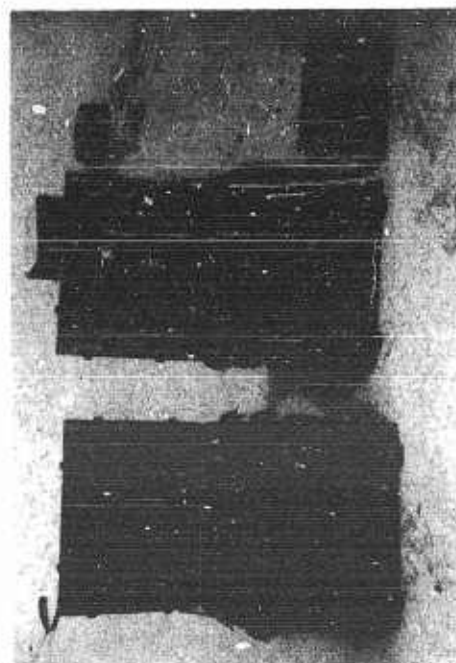
Fig. 3.138 Shot 9, Test Group 69, Signal Supply Point. (Top left-before, Top right-after, Bottom left, close-up of AN/TRC-1 Radio Set in Chests, Bottom right, close-up of AN/TRC-1 Radio Set, Chests open to Show Condition Inside.) 5625 ft, 24.5 cal, 5.4 psi, 80 r at Surface.

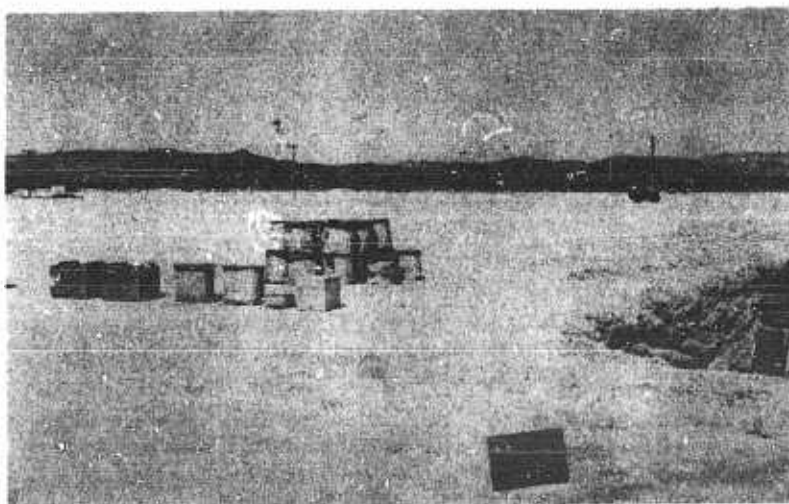
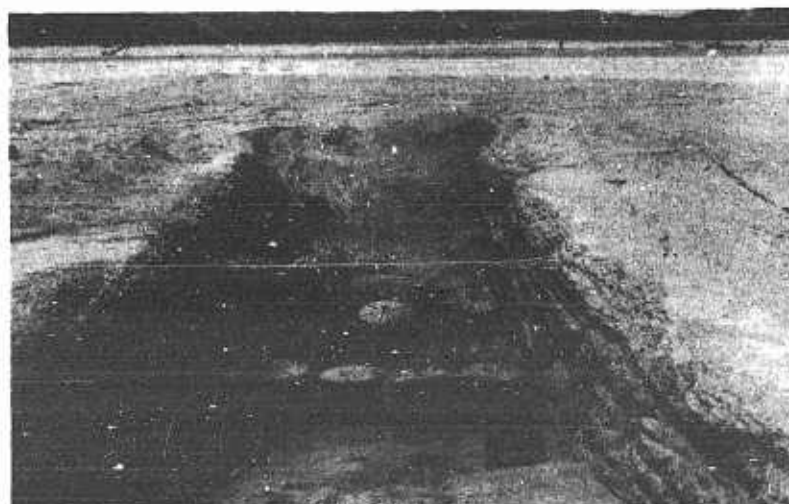
Fig. 3.139 Shot 9, Test Group 102, Signal Supply Point in Open Pit. (Top-before, Bottom-after) In Top View the Open Pit can be Seen to the Right of the Signal Supply Point on the Surface. 3150 ft, 55 cal, 10.2 psi, 1160 r at Surface.

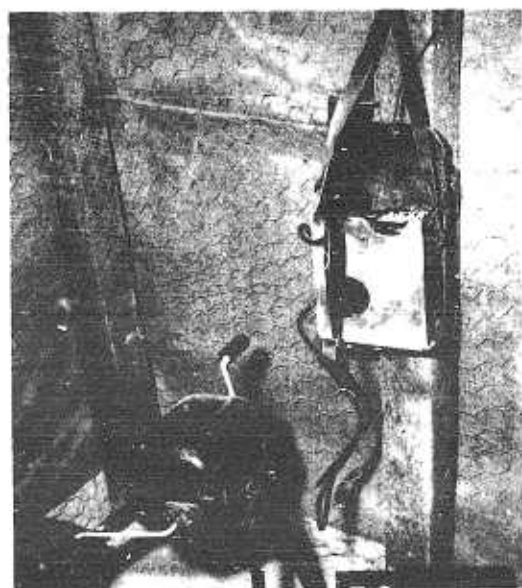
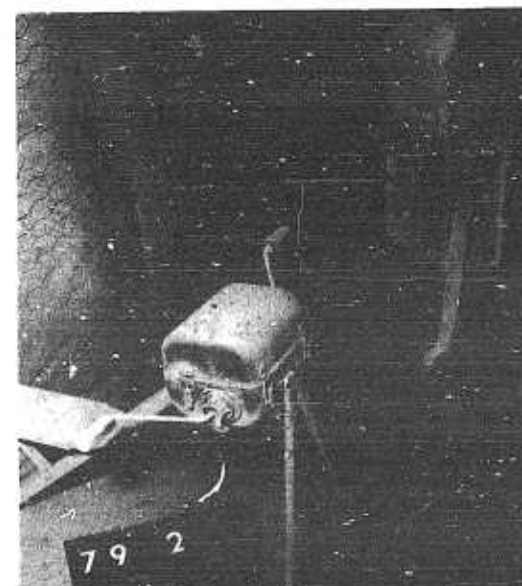
Fig. 3.153 Shot 9, Test Group 79, Signal Corps Items in Corps of Engrs. Installations (CO Type CP-Fig. 3.124). SB-22 Switchboard (Top left-before, Top right-after; GN-94 Generator and EE-8 Telephone (Bottom left-before, Bottom right-after) 4000 ft, 41 cal, 8 psi, 400 r at Surface.

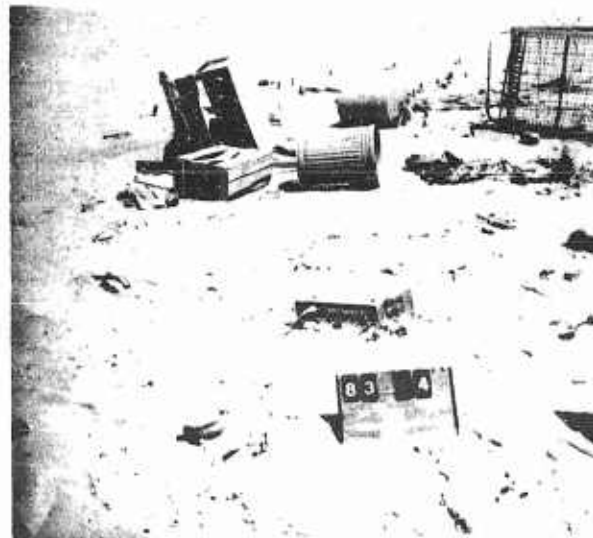
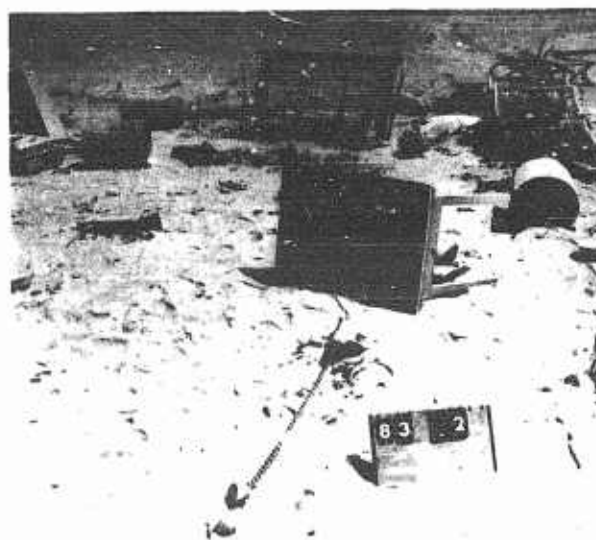
Fig. 3.154 Shot 9, Test Group 83, Signal Corps Items in Medical Corps Installations. (Field Hospital in Tents at the Surface.) (Top left-before, Bottom left-after; Top right, SB-22 Switchboard-after, Bottom right, close-up of Same Switchboard-after) 4125 ft, 39.5 cal, 8 psi, 320 r at Surface.

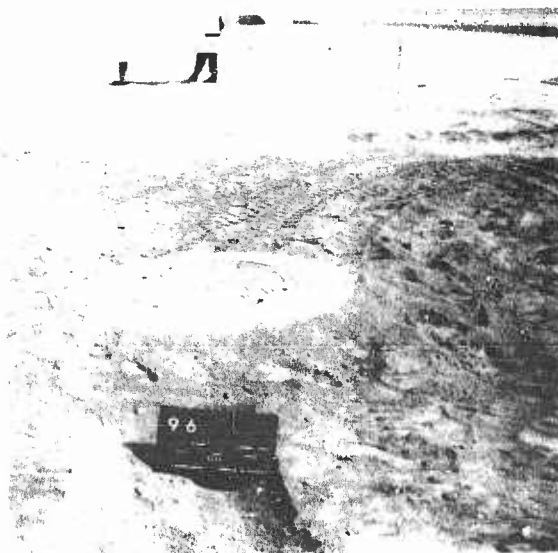
b. RESULTS: The manhole cover in Shot 9 (1250 ft, 113 cal, 16.6 psi), was lifted from its base and moved 1/2 in. There were several

Fig. 3.156 Shots 9 and 10, Test Group 96, Manhole. (Top left-before 9, Bottom left-after 9; Interior of Manhole, Top right-before 9, Bottom right-after 9.) NOTE: The Manhole was destroyed in Shot 10. Shot 9 - 1250 ft, 113 cal, 16.6 psi. Shot 10 - 600 ft, over 65 cal, over 115 psi.
